## CHAPTER 5

### RESTORING STONework

#### RESEARCH

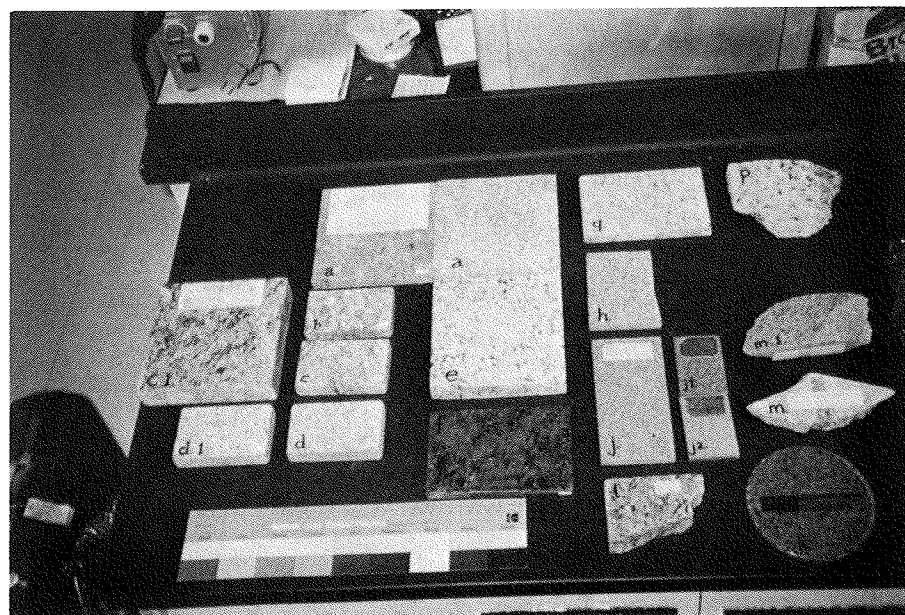
This group of granites from the United States shows the great diversity which is to be found even within such a small selection. (a) and (e) are Stoney Creek granites from Rhode Island. (c, c1) Grey Tapestry granite from the Baretto Granite Corp. New Hampshire. (f) is a Cold Spring Granite Co., Spring Green (i, j1, j2) are Westerly blue, light and pink granites from Rhode Island. (l) is a Cold Spring Texas Red granite. (m) is a Barre blue grey granite from Vermont.

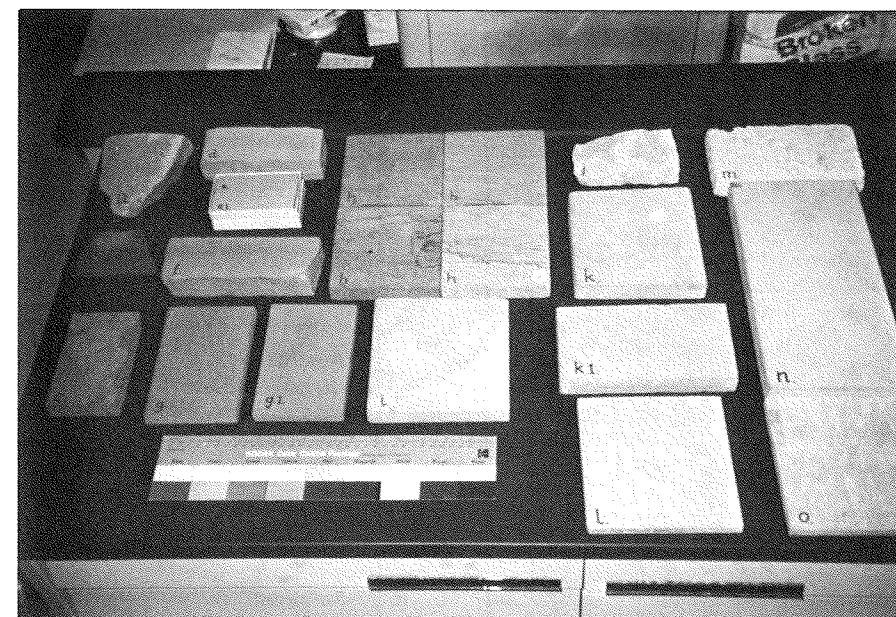
Similarly this group of sandstones and limestones from the United States again illustrates rich diversity. (b) and (c) are Bluestones from the Catskills, New York State. Two samples marked (e, e1) are Scioto sandstones from Ohio. Four examples marked (h) are Briar Hill sandstones from Ohio. (i) is a Berea sandstone from South Amherst, Ohio. (k, k1) and (n) are Indiana limestones with various finishes. (m) is a Texas shellstone, a fossiliferous limestone.

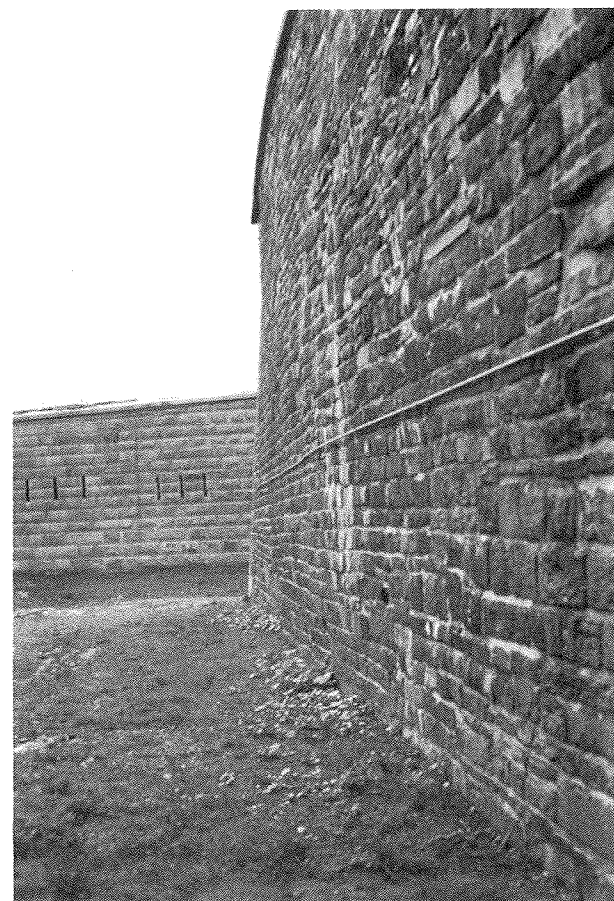
Bulging wall face caused by loss of internal mortar.

Where the inner and outer wythes are insufficiently bonded together the outer wythe frequently buckles outward under load, first developing a major bulge and then possibly even collapsing. The buckling will often occur because of differential loading on the inner and outer wythes.

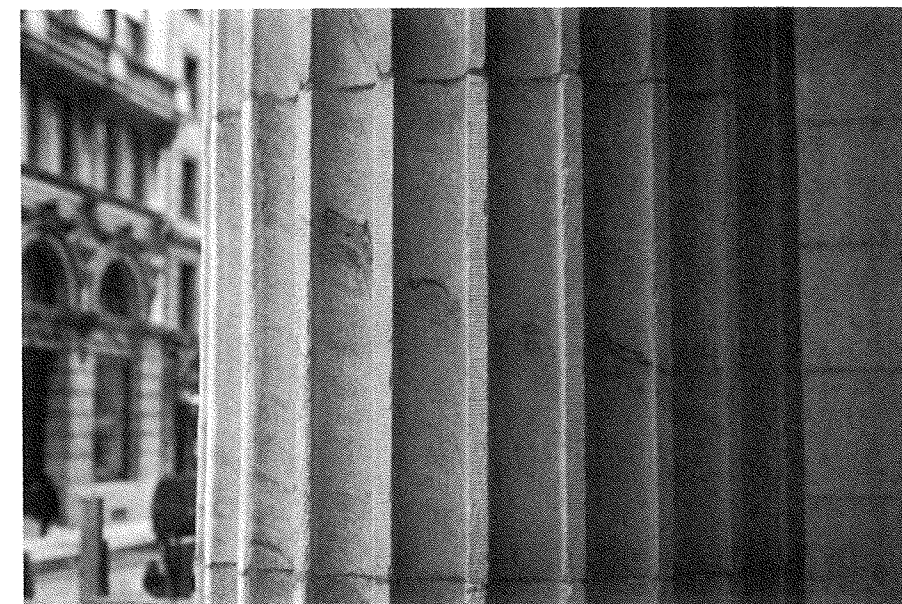
Acid soluble stone; note the damage to left face which was exposed to the rain.

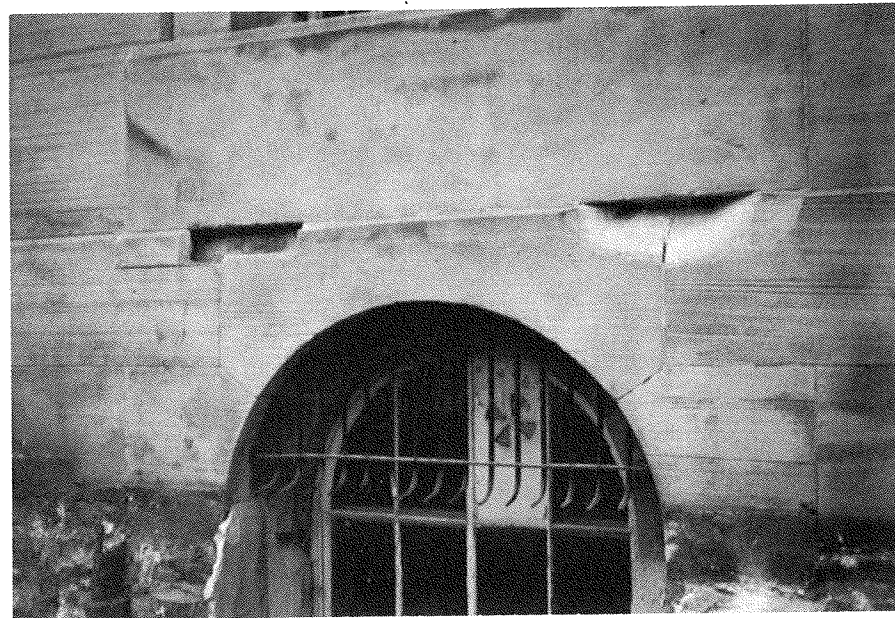
Oswego Custom House, iron cramps set in sulfur corroded and shattered stone masonry.

**Were Metal Clamps, Dowels or Other Forms of Fixings or Connectors Used in the Masonry and if so Were They Made of Iron or Steel Which has Corroded and Expanded, Shattering the Surrounding Masonry?** Such corroded metal work is often most conveniently cored out using diamond-tipped coring bits of appropriate diameters. I have worked on the restoration of the 1858 Oswego, New York, Customs' House where thousands of dollars worth of damage had been caused by corroding cramps shattering sandstone blocks. In this case the cramps were originally set in molten sulfur or "brimstone" which contributed to the corrosion when acid rain penetrated to the wrought-iron cramps. In such cases all traces of the sulfur must be removed in addition to the corroded iron.

Where iron or steel cramps or dowels have corroded and shattered surrounding stonework through the expansion of their corrosion products, it is essential to remove the corroded remains and sulfur settings where these exist. A new cramp or dowel of a noncorroding metal such as an appropriate type of stainless steel may then be substituted for the original.

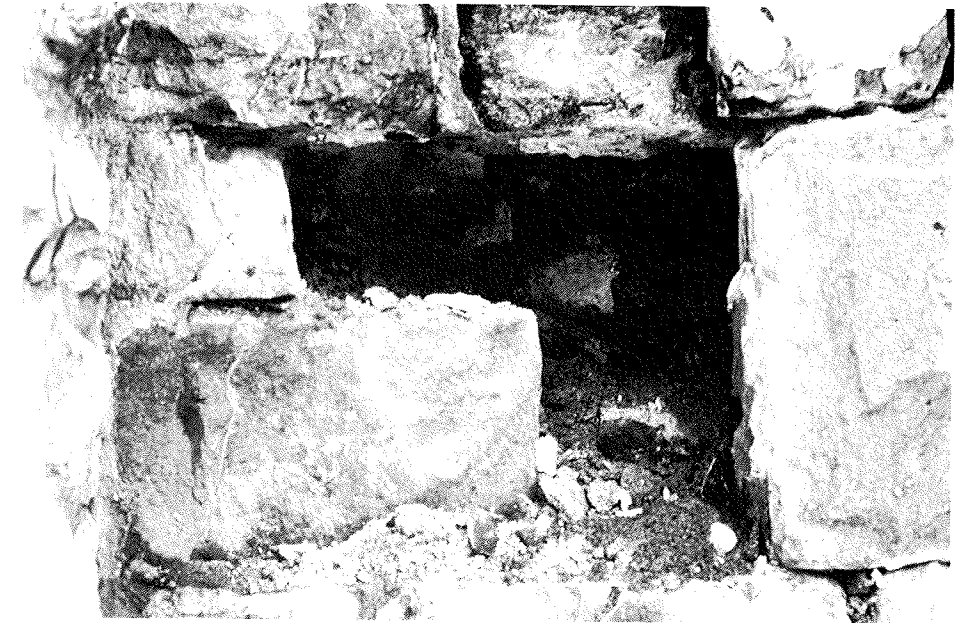
Mortar turned to sand by prolonged penetration of acid rain, St. Mary's Cathedral,  
Kingston, Ontario.

**What are the Nature and Condition of the Mortar in Which the Stones Were Laid?** Earlier mortars tend to be based on lime rather than hydraulic cements. Lime mortars are acid soluble and tend to be very badly damaged by acidic rainwater and snow melt water if leaks and cracks are left unattended for years. Ultimately the lime is removed and only wet sand remains. The deposition of sheets of redeposited carbonates on external surfaces of walls and on the soffits of arches are sure indicators that lime is being removed from within the wall and that the wall is being seriously weakened in the process.

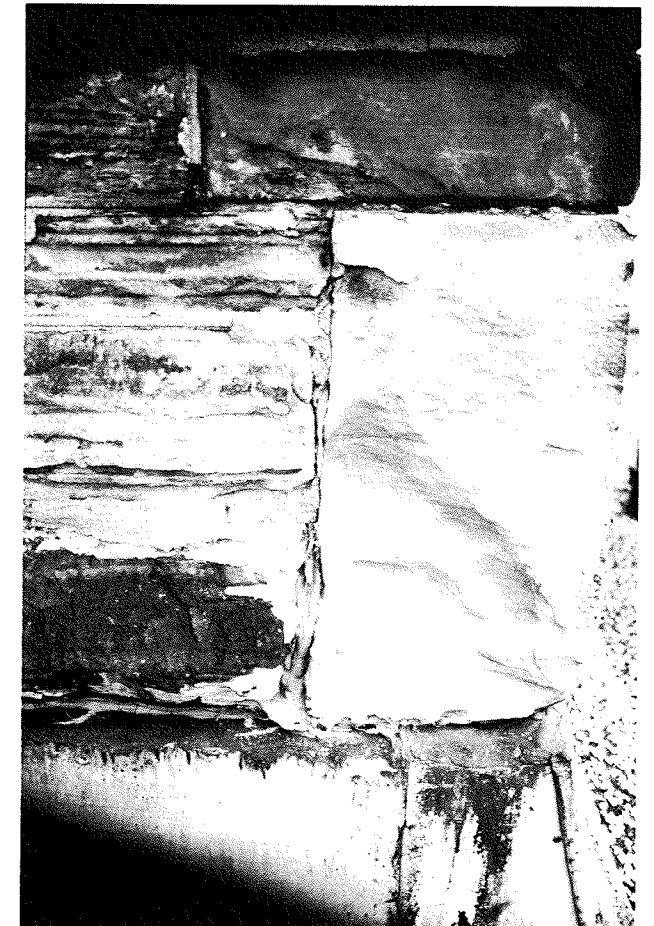
Two different types of sandstone weathering differently on  
the corner of a tower. The Ohio sandstone on the right is  
suffering from "alveolar erosion" caused by wind vortices  
and the increased deposition of water soluble salts caused by  
higher evaporation rates at the corner.

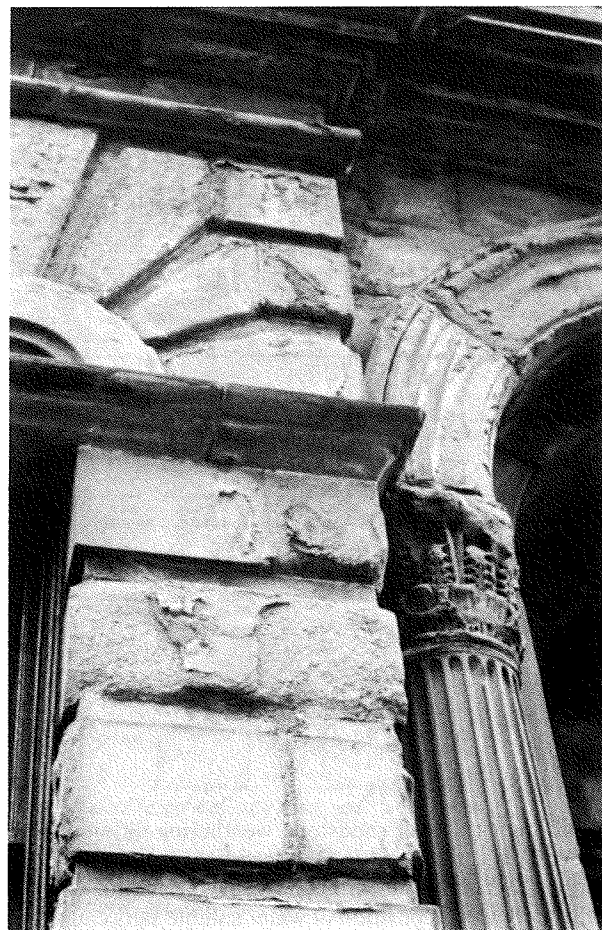
Red sandstone blocks in a wall show what at first looks like "face bedding" problems, until close inspection reveals that the surface is exfoliating on all faces. The problem is caused by extreme physical and chemical changes in the surface crust.

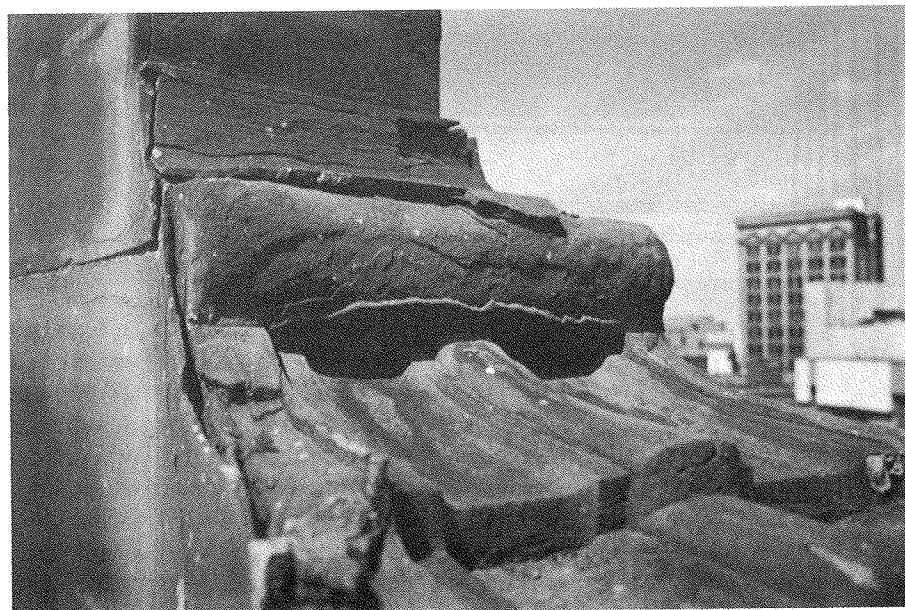
Contour scaling in red sandstone.

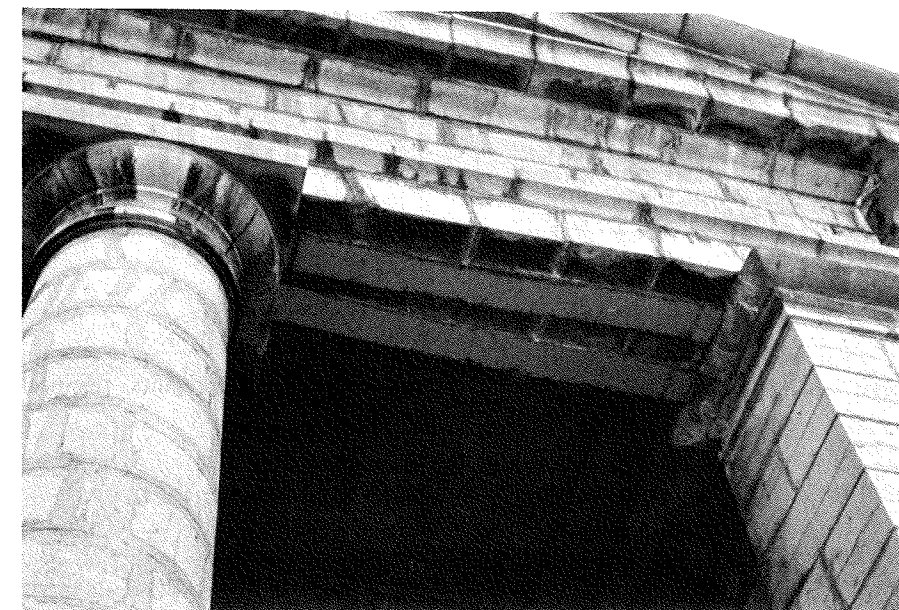
Stabilized and restored voussoired stone beam; before and after views, 1840's Gatehouse, Kingston Penitentiary, Ontario.

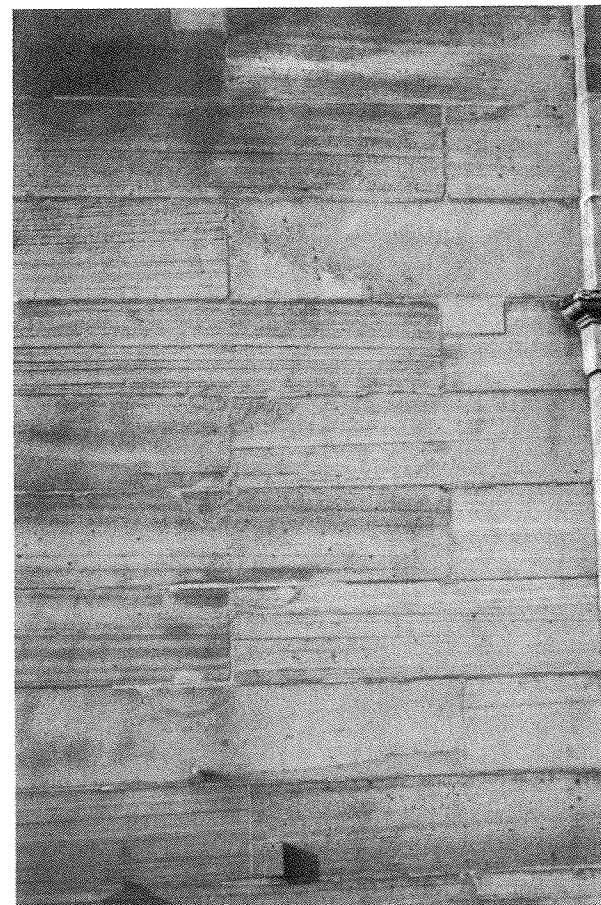
Repairs of cramp shattered stonework, Oswego, NY.

I have found that the easiest way to remove such corroded remains which may be jammed into the stone, is to drill them out with water-cooled diamond-tipped coring bits. Problems with mortars and repointing raise many major issues which are discussed in Chapter 7.

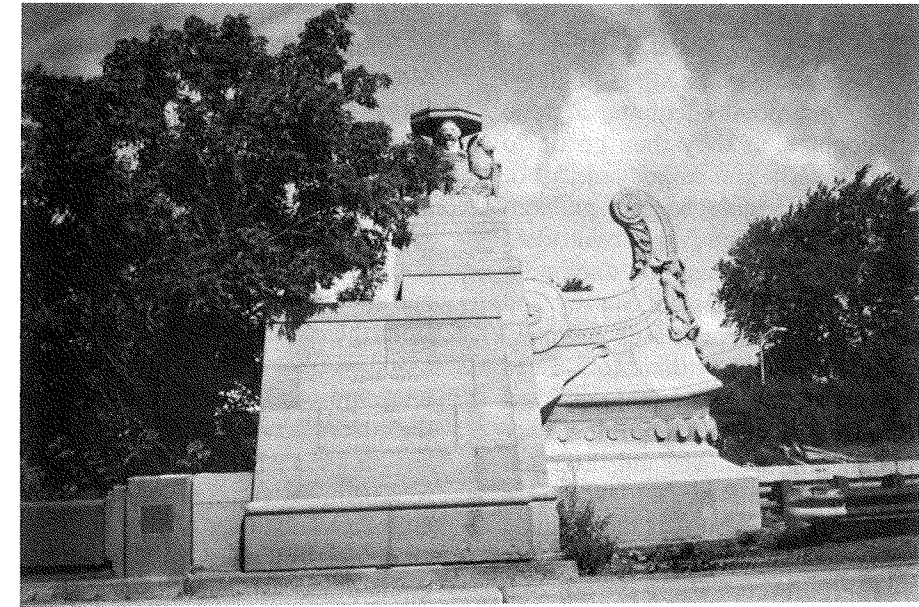
Median Monument, Queen Elizabeth highway bridge. St. Catherine's, Ontario. Further surface exfoliation was prevented by treating the stone surface with a water repellent.

I worked on a case where an oligomeric alkylalkoxysilane from the Conservare range of products was used to protect the surfaces of some vintage bridge pylons and median monuments built of dolomite. Fast moving trucks and cars constantly bombarded the surfaces of the stone with high velocity sprays of polluted water from puddles, causing deep penetration of pollutants and consequent damage. The additional feature of the alkali resistance of the selected repellent makes it an almost essential conservation material in this case because it will not be affected by the alkalis in fresh mortar or concrete used in the restoration work. Conservators generally agree that most water-repellent treatments are carried out unnecessarily and have added what may have been a substantial cost for no particular benefit. Most water repellents break down after a number of years and cease to function. Unfortunately, they do not break down evenly and can cause unsightly blotches and patches on surfaces as they deteriorate. Having broken down, water repellents then require replacement but difficulties of access usually prevent this essential maintenance.
